AFWAL-TR-82-2057 Volume I

HIGH VOLTAGE TESTING: TEST PROGRAM REPORT

Final Report for Period 29 September 1979 - 1 July 1982

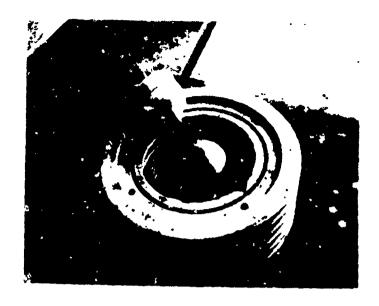
Figure 6.4-5: Test Fixture Electrodes

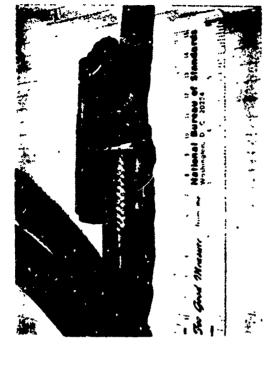
Figure 6.5-2: Shield Band Failed

The cable assembly A-2 was tested to 120 kV peak. Following the test, the test data waveform indicated an insulation breakdown. The cable was examined and a puncture was visible at the cable shield termination, Figure 6.5-1. The termination was dissected and the insulation flaw was found to be between the primary insulation and the shield extending into the primary insulation toward the inner conductor, Figure 6.5-2. In Figure 6.5-3, the delaminated insulation system is exposed. Shown is a crack and a very dark spot where the arcing occurred. The bright area indicates an unbonded section near the shield termination - an air filled void.

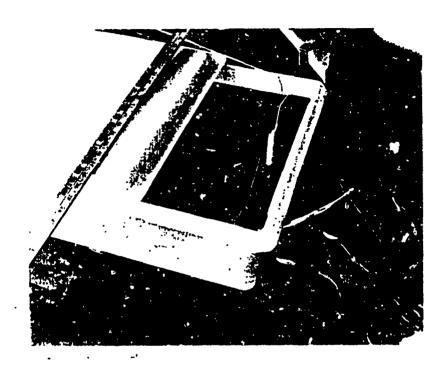
Figure D3. Picture of Flash Due to 210 KV Surge Pulse Onto Secondary Winding.
